## U.S. Department of Labor Mine Safety and Health Administration

## Fatalgrams and Fatal Reports

Fatality #40 - October 12, 2006 Fall of Roof - Underground - AL Jim Walter Resources Inc - No 7 Mine

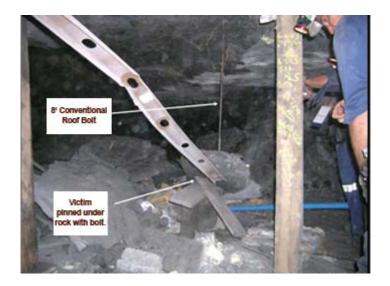
**COAL MINE FATALITY -** On Wednesday October 12, 2006, a mine supervisor, with 23 years of mining experience and 20 at this mine, was fatally injured by a roof fall. The victim was checking ventilation controls in an area mined in 1984 prior to a planned increase in fan pressure. When he had not reported out of the mine after several hours, a search was conducted. He was found in his reported travel area, under a 7-ft. by 3.5-ft. by 7-in. piece of roof rock. The area was supported by 8-ft. conventional roof bolts and was no longer part of a mine examiner's route.

- Take extra precautions when traveling in older mine areas, paying particular attention to deteriorating roof conditions.
- Thoroughly examine the roof, face and ribs, immediately before starting any work, including traveling and routine observations.
- Remain alert for changing roof conditions.
